## **Analysis of Road Pavement Conditions Using the Surface Distress Index (SDI) and International Roughness Index (IRI) Methods Based on the RoadLab Application on the Gunungwungkal–Sumberrejo Road Section, Pati, STA 0+000–3+000**

**Muhammad Mudofar<sup>1\*</sup>, Nabil Kharisma Aji<sup>2</sup>, Rachmat Mudiyo<sup>3</sup>, Juny Andry Sulistyo<sup>4</sup>**

<sup>1-4</sup> Universitas Islam Sultan Agung, Semarang, Indonesia  
email: [mudofarmuhammad78@gmail.com](mailto:mudofarmuhammad78@gmail.com)<sup>1</sup>

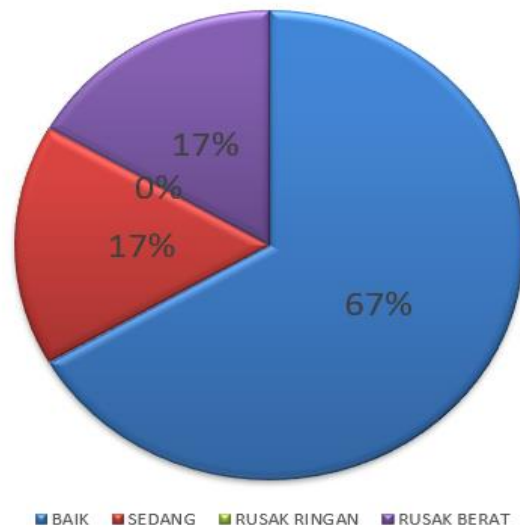
Figure 1. Recapitulation of SDI Condition Percentage

The distribution of pavement conditions provides a more detailed interpretation of the segment-level SDI results. Based on the original analysis, 67% of the observed segments were categorized as good, 17% as fair, 0% as lightly damaged, and 17% as heavily damaged. The distribution indicates that although the calculated average SDI falls within the heavily damaged category, most individual segments were classified as good. This apparent difference results from the presence of several segments with very high SDI values that substantially increase the overall average. The condition distribution therefore highlights the importance of examining both central tendency and segment-level classification when interpreting pavement performance. From a maintenance perspective, the heavily damaged segments should receive greater attention because localized severe deterioration can affect road safety and accelerate the deterioration of adjacent pavement areas.

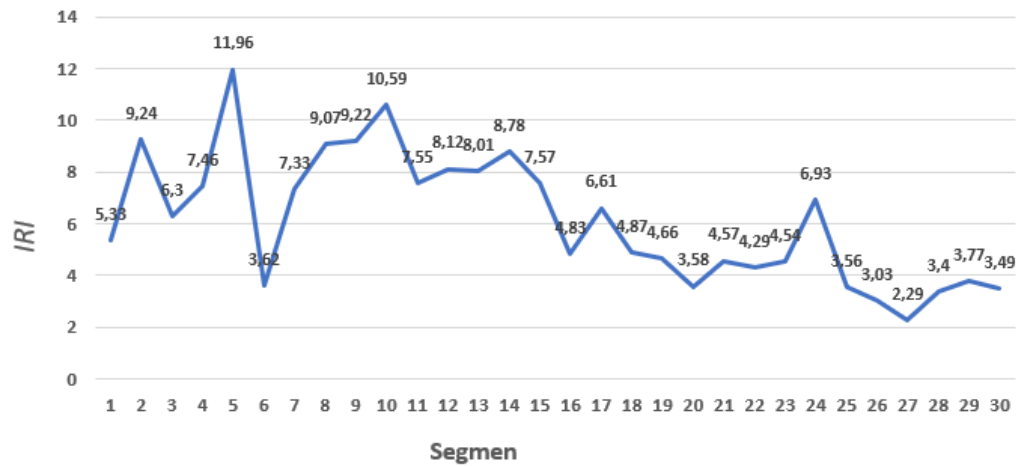
Figure 2. IRI Profile Graph of Gunungwungkal–Sumberrejo Road, East–West Direction

The East–West IRI profile demonstrates that several segments experienced relatively high surface roughness. Segments 2, 5, 8, 9, 10, 12, 13, and 14 were classified as lightly damaged, with IRI values generally exceeding 8 m/km. Segment 5 exhibited the highest IRI value of 11.96 m/km, followed by Segment 10 at 10.59 m/km and Segment 2 at 9.24 m/km. In contrast, Segments 25–30 recorded comparatively low IRI values ranging from 2.29 to 3.77 m/km and were classified as good. The concentration of higher IRI values in the earlier and middle portions of the road indicates that surface unevenness was not uniformly distributed along the survey route. High roughness values can reduce driving comfort because greater longitudinal unevenness causes more pronounced vehicle vibration

during travel. The East–West profile therefore identifies specific segments where pavement smoothness is substantially lower than that of the later road sections. These findings provide a functional perspective that complements the visible distress information obtained through the SDI assessment.

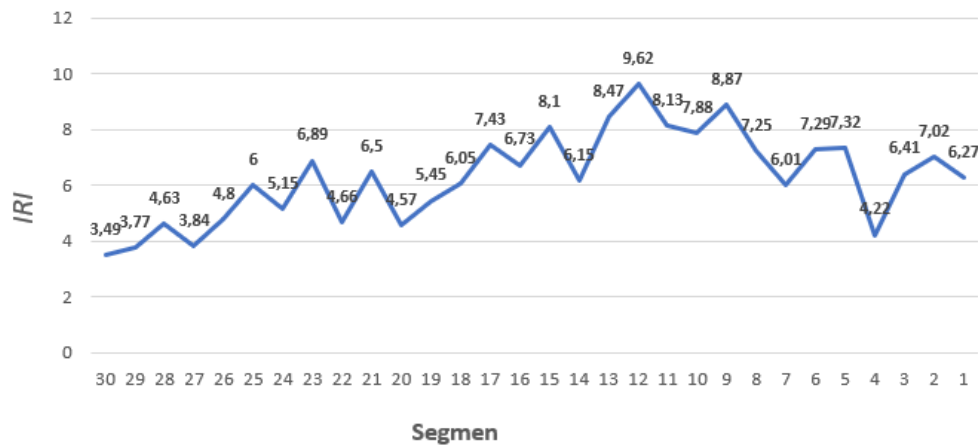
Figure 3. IRI Profile Graph of Gunungwungkal–Sumberrejo Road, West–East Direction

The IRI measurement was also conducted in the opposite West–East direction to examine pavement roughness from the reverse travel path. The results show that IRI values in this direction ranged from 3.49 to 9.62 m/km across the 30 segments. The lowest value was recorded at Segment 30 with an IRI of 3.49 m/km, while the highest value occurred at Segment 12 with an IRI of 9.62 m/km. Segments 15, 13, 12, 11, and 9 recorded relatively high values and were classified as lightly damaged, with IRI values of 8.10, 8.47, 9.62, 8.13, and 8.87 m/km, respectively. Meanwhile, the initial reverse-direction segments, particularly Segments 30, 29, and 27, showed comparatively low IRI values and were classified as good. The remaining segments were predominantly classified as fair, indicating moderate roughness along much of the survey route. The West–East measurements therefore show a different distribution of roughness compared with the East–West measurements, although several locations exhibited similar patterns of elevated IRI.

The comparison of the two IRI measurement directions indicates that pavement roughness varied according to both location and survey direction. The original analysis reported that the West–East direction generally showed a relatively smoother pavement condition than the opposite direction, allowing road users to experience comparatively better riding comfort. The difference between directions is evident in several segments where the IRI values changed considerably despite representing the same physical road section. Such variation may reflect differences in the measured vehicle trajectory, lane position, or localized pavement irregularities encountered during each run. The findings demonstrate that repeated directional measurements can provide a more comprehensive representation of pavement roughness than relying on a single measurement path. The overall IRI assessment reported an average roughness value of 0.4 m/km and classified the road condition as good. The segment-level distribution, however, still identified several sections with fair and lightly damaged conditions, indicating that localized roughness remained present despite the favorable overall assessment.
